**MODIFICATIONS TO THE TUBE-LAUNCHED, OPTICALLY  
TRACKED, WIRE-COMMAND MISSILE LAUNCHER FOR  
THE BRADLEY FIGHTING VEHICLE SYSTEM**

Report Number 98-165

June 25, 1998

**Office of the Inspector General  
Department of Defense**

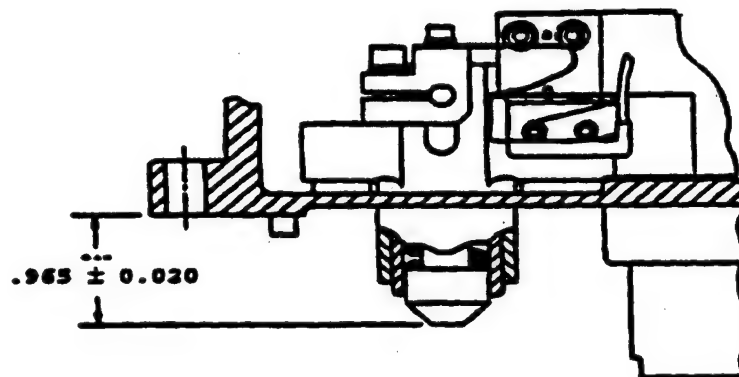
Figure 3. Umbilical Switch Specification

**Alignment of Umbilical Switches.** The DMWR requires the gauge set to align and test the ACU umbilical switches S1, S2, S3, and S4. Switches S1 and S2 are associated with the inboard launcher tube, while S3 and S4 are associated with the outboard launcher tube. The S2 and S4 switches, when activated, signal that a missile is present. The S1 and S3 switches, when activated, signal that a missile has been selected. According to the design specifications, those umbilical switches should be aligned to activate when the bottom of the holdback pin plunger is 0.965 inches, plus or minus 0.020 inches, from the bottom of the ACU housing as shown in Figure 3.

The S1 through S4 gauge assembly of the gauge set is used to measure the depth of the holdback pin plunger at the time the umbilical switches have been activated.

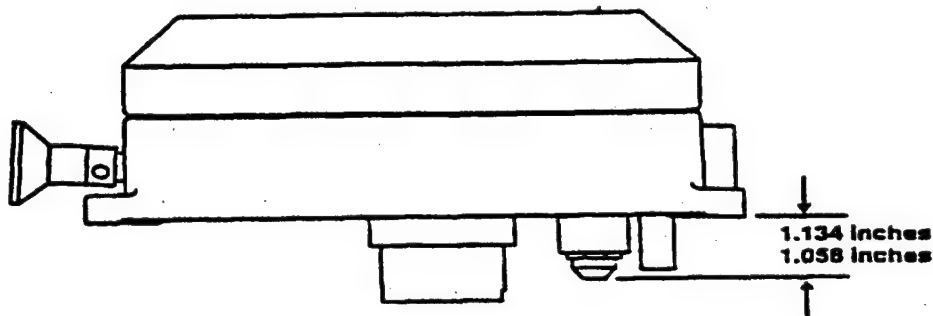
**Figure 4. Holdback Pin Plunger Depth Specification**

**Alignment of Motor Stop Switches.** The DMWR requires the gauge set to align and test motor stop switches S5 and S6. The S5 switch is the electrical limit switch for the extend function of the ACU motor. The S6 switch is the electrical limit switch for the retract function of the ACU motor. The S5 and S6 settings affect the distance that the holdback pin plunger and umbilical cable are extended when arming the system and retracted when disarming the system. The gauge set, specifically the S5 gauge assembly is required to ensure that the holdback pin plunger depth in relation to the ACU housing is between 1.058 inches and 1.134 inches, as shown in Figure 4, in order to satisfy design specifications.
